DAM SAFETY INSPECTION REPORT

INVENTORY No.: TX07192

DAM: Camp Branch Acres Dam

CURRENT INSPECTION DATE: October 18, 2023

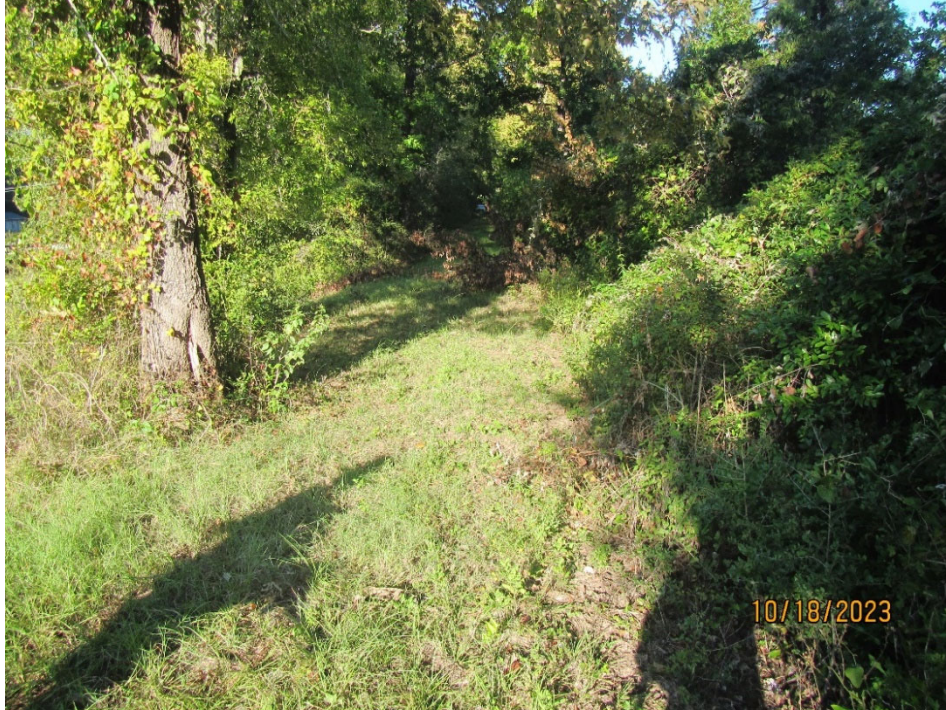
- The 12-foot-wide crest of the dam had a sparse grass cover with some bare soil areas throughout the length of the crest.
- Several areas along the crest had brush and tree growth from the slopes encroaching onto the crest.
- The crest was found to be in fair condition.

Photo 1. View of the crest looking right from the left end of the dam. Note the dense brush and tree growth along the slopes beginning to encroach the crest.

3. All excessive non-grassy vegetation, brush, scattered and piled dry wood debris, dead tree trunks, and tree growth with a trunk diameter less than 4 inches should be removed from the dam embankment's crest, slopes, spillway, and the area located within 15-20 feet of the downstream toe of the dam. After removal, a short grass cover should be established over the affected and bare soil area(s). A short grass cover provides an ideal surface to protect against erosion, prevents harborage for burrowing animals, and allows for easier detection of incipient problems. Mowing should be performed as needed (prior to any future inspections (including owner inspections), and/or typically not less than twice yearly).

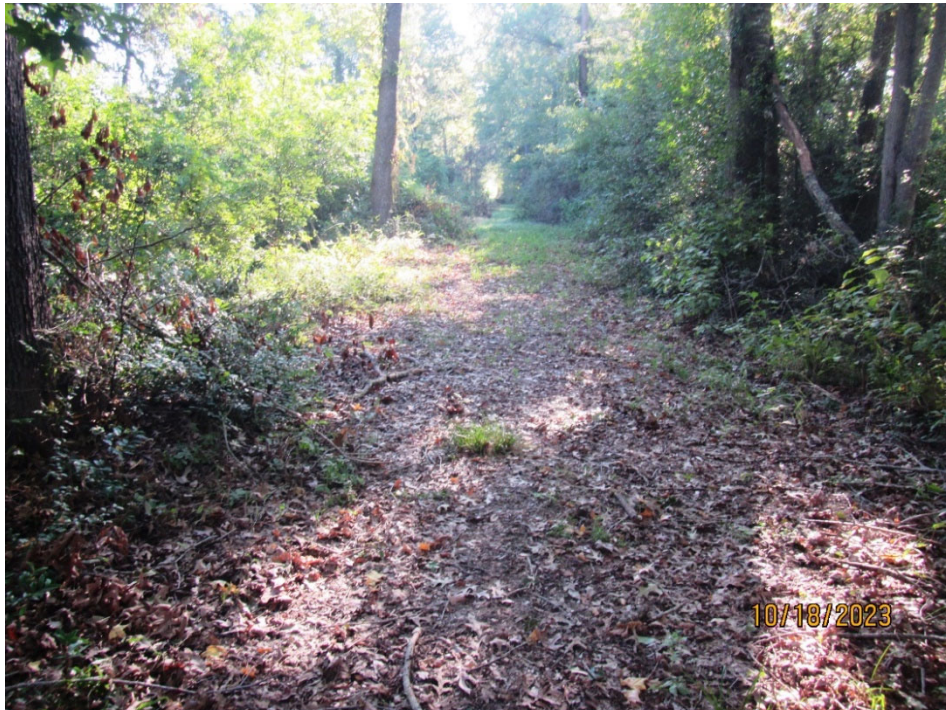
Photo 2. View of the crest looking left from the right end of the dam. Note the brush and tree growth along the slopes and the lack of grass cover along the crest.

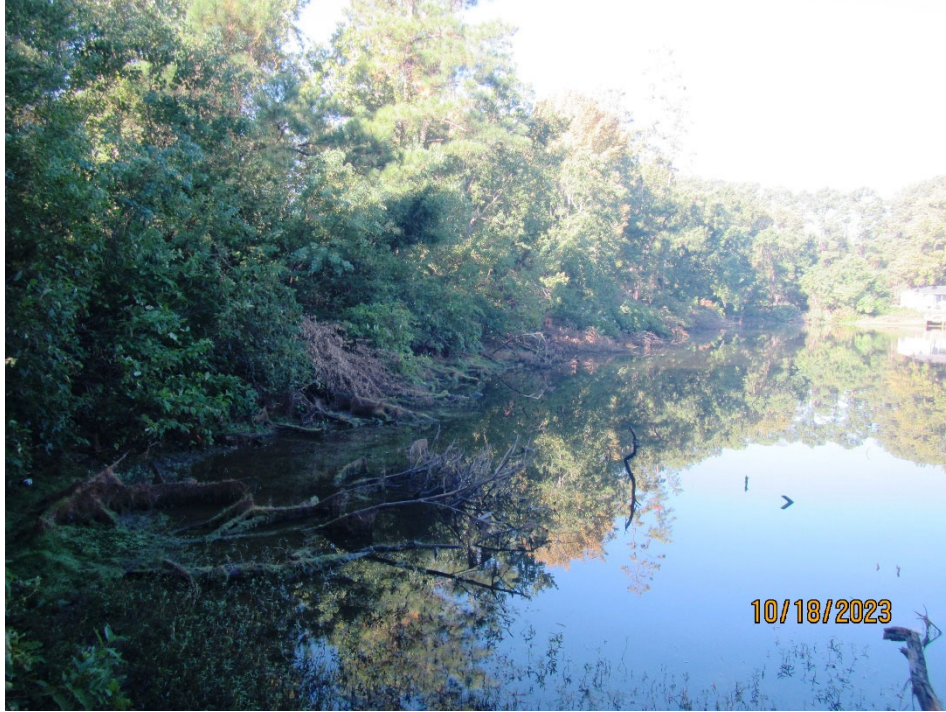
- The 3 horizontal to 1 vertical [3H:1V] upstream slope of the earthen embankment was densely overgrown, resulting in a limited inspection of the slope.
- Several areas of the slope had been cleared of some brush and tree growth.

- Dry wood and cut-tree debris were scattered throughout the upstream slope.
- Several burrows were observed throughout the length of the slope. One of the burrows measured to be about 2-feet deep and located near the middle of the dam.
- The upstream slope was found to be in poor condition due to the densely overgrown condition of the slope.

Photo 3. View of the upstream slope looking right from the left end of the dam. Note the dense brush and tree growth along the length of the slope.

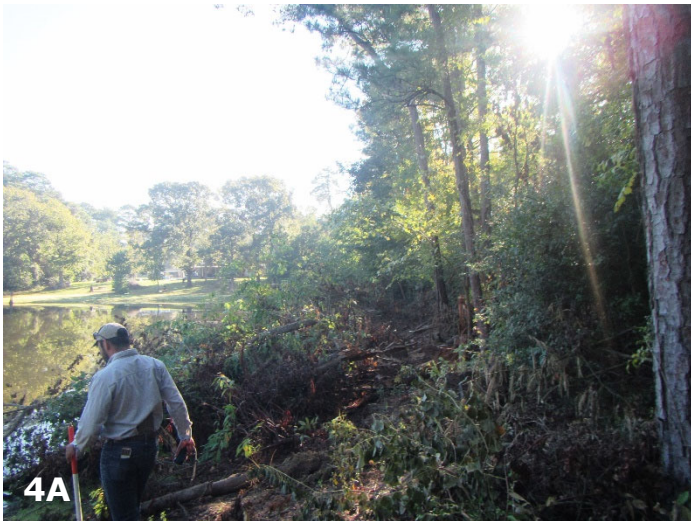
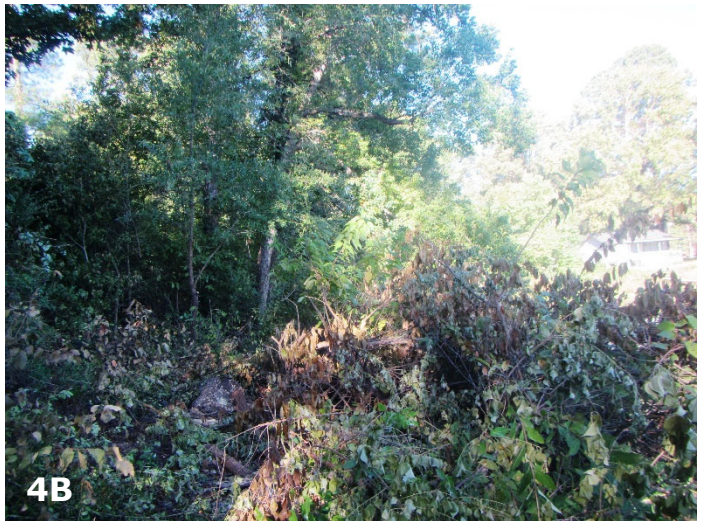
Photos 4A & 4B. Views of the upstream slope looking left and right (respectively) from the near middle of the upstream slope. Note this area had been partially cleared compared to the rest of the slope; however, cut vegetative debris and tree trunks were still on the slope.

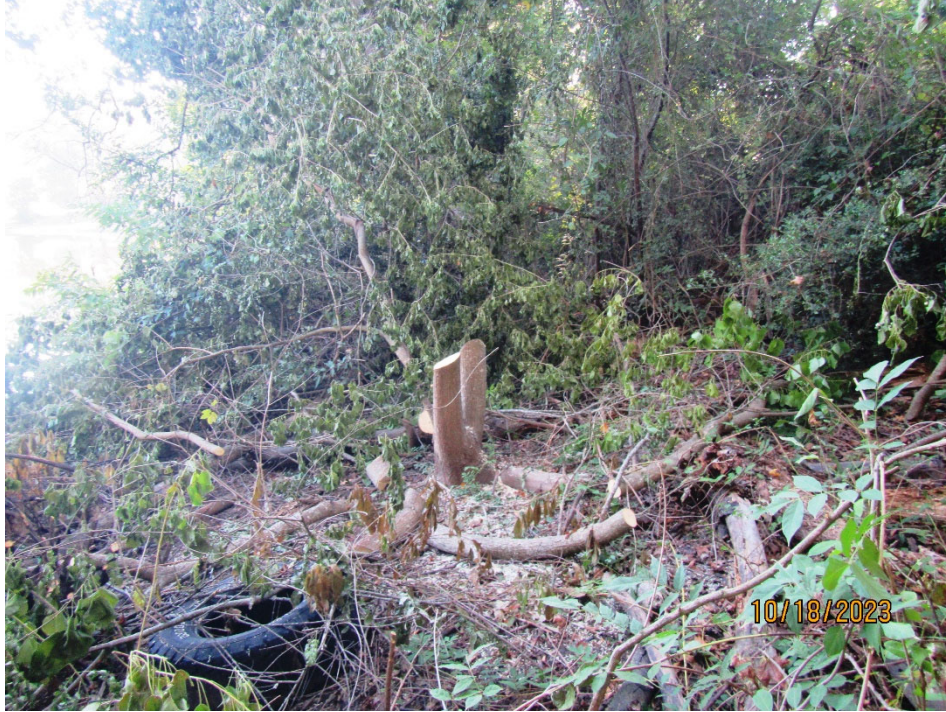
Photo 5. View of some partial clearing as seen by the remaining small tree trunks. Note some non-vegetative debris observed within the dense brush.

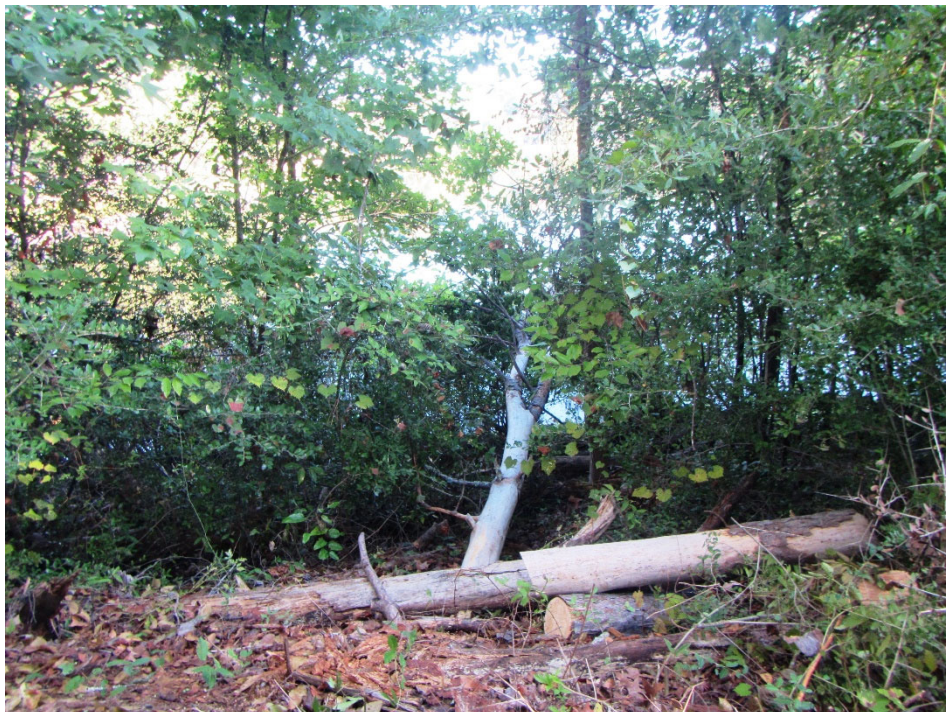
Photo 6. View of a downed tree along the crest/upstream slopes edge, near the mid-right side of the dam.

- a. Trees that are larger than 4 inches in diameter may remain until their natural death, at which time the tree and roots are to be removed, the resulting holes backfilled with properly compacted non-dispersive clay, and a vegetative cover established. Removal of larger trees and backfill repairs should be supervised by a PE with dam experience. Additionally, the larger tree canopy cover should be thinned out and be pruned up high to facilitate mowing and light penetration to allow for vegetative grass cover to establish on the bare soil areas of the crest and slopes.

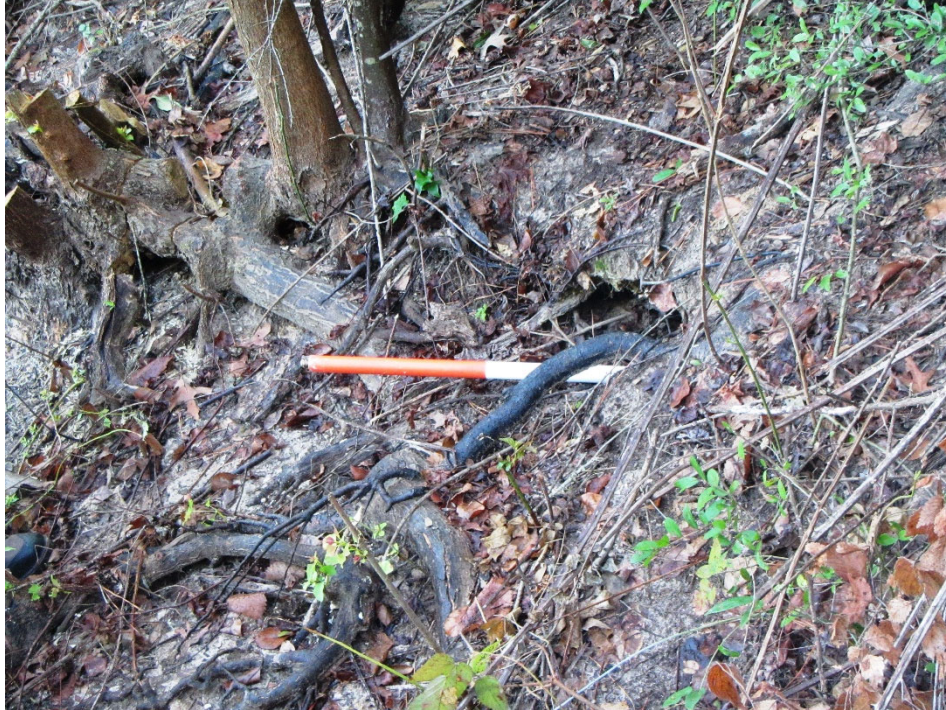
Photo 7. View of a burrow along the upstream slope, about 2-feet deep, near the middle of the dam.

4. Animal burrowing was observed throughout the dam. Nonetheless, it is likely that any other burrows or other animal activity may have been hindered and missed due to the dense vegetative growth. If additional animal burrowing is located upon clearing the slopes, then burrows should be backfilled and properly compacted with non-dispersive fill and a grass cover should be re-established. It should be noted that animal burrowing activity can create flow paths and can otherwise weaken the integrity of the embankment. Assistance in removing nuisance animals can be obtained from the Texas Wildlife Services Program.

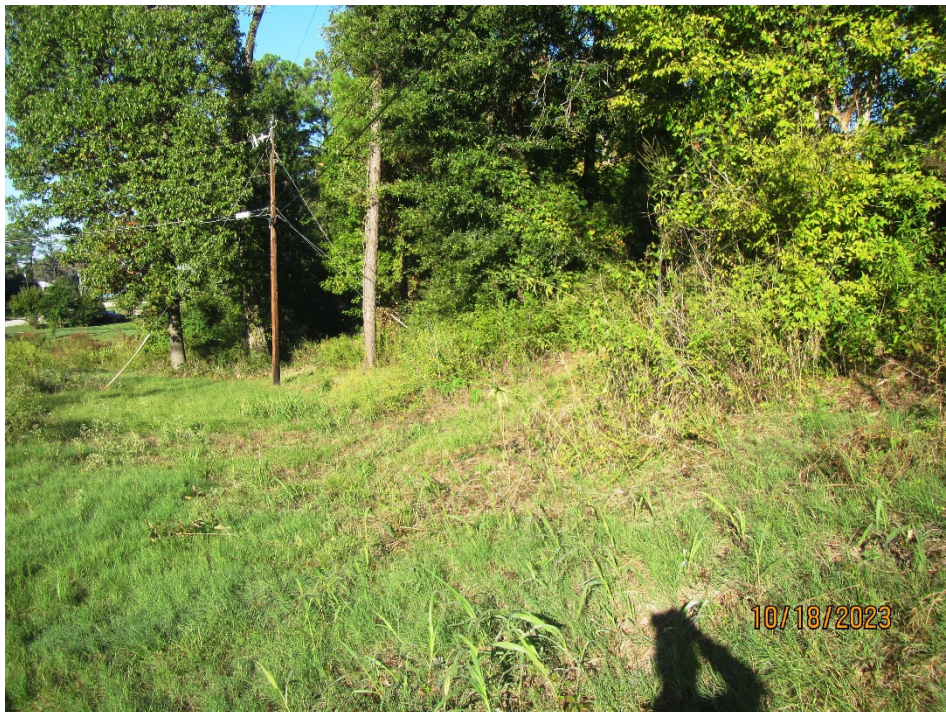
- The 3H:1V downstream slope of the earthen embankment was densely overgrown, resulting in a limited inspection of the slope.
- Several areas of the slope had been cleared of some brush and tree growth.
- Dry wood and cut-tree debris were scattered throughout the downstream slope.
- Several burrows were observed throughout the length of the slope. One of the burrows measured to be about 1.7-feet deep and located near the mid-left end of the dam.
- A trail was observed on the downstream slope near the middle of the dam. Exposed tree roots were observed crossing the trail as a result of run-off erosion.
- The previously observed staired foot path and handrail were located near the mid-right end of the dam and appeared unchanged from the last inspection.
- The downstream slope was found to be in poor condition due to the densely overgrown condition of the slope.

Photo 8. View of the densely overgrown brush and tree growth along downstream slope looking right from the left end of the dam. Note the utility lines traverse across the length of the downstream toe area.

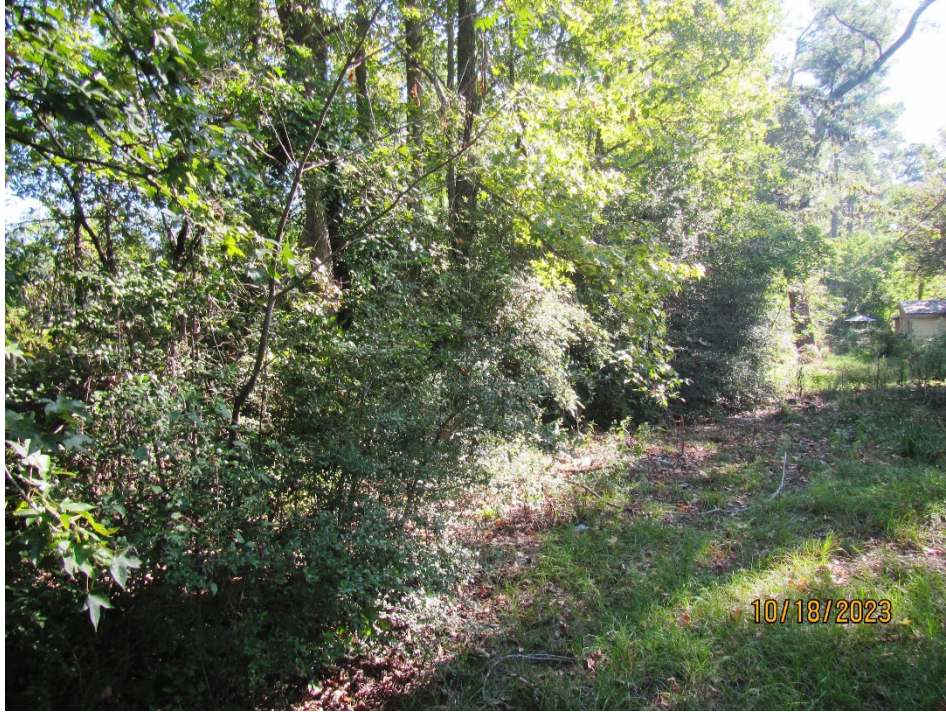
Photo 9. View of the densely overgrown brush and tree growth along the downstream slope looking left from the right end of the dam. Note the habitable residences along the downstream toe area.

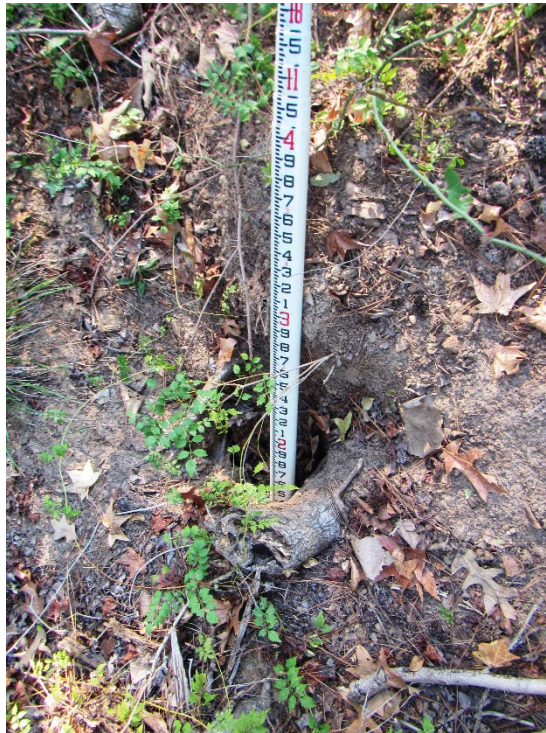
Photo 10. View of a burrow along the downstream slope, about 1.7-feet deep, near the mid-left end of the dam. Note the dead tree roots adjacent to the burrow.

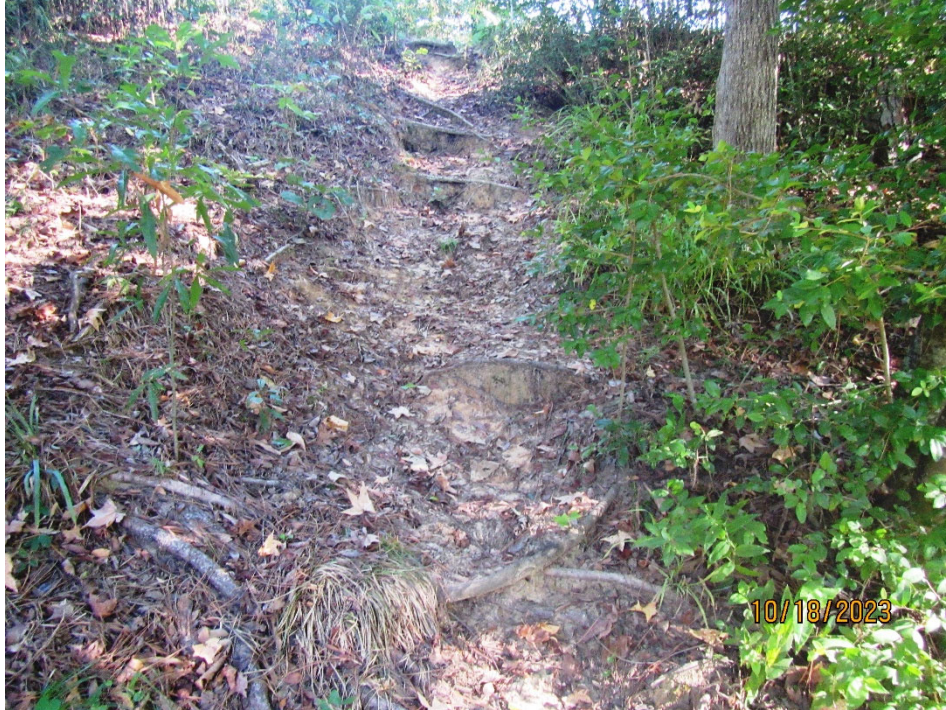
Photo 11. View of a trail observed on the downstream slope near the middle of the dam. Note the exposed tree roots crossing the trail as a result of runoff erosion.

- a. Monitor the minor erosion observed on the trail and staired path.
- b. Routine safety inspections should be conducted on a periodic basis and immediately after a significant rain event to evaluate the condition of the structure and detect and address problems before they progress to a serious level. These actions will minimize cost of dam maintenance and repair activities as well as minimize risks and liabilities associated with dam safety issues.

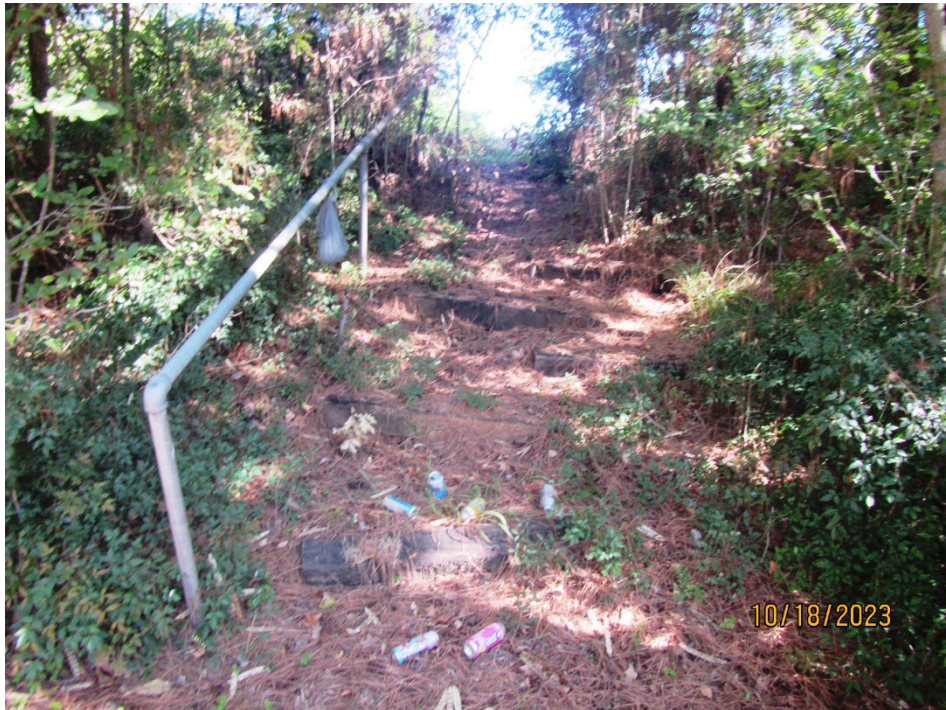
Photo 12. View of a staired foot path and handrail along the downstream slope near the mid-right end of the dam. Note the railroad ties used as steps along the slope.

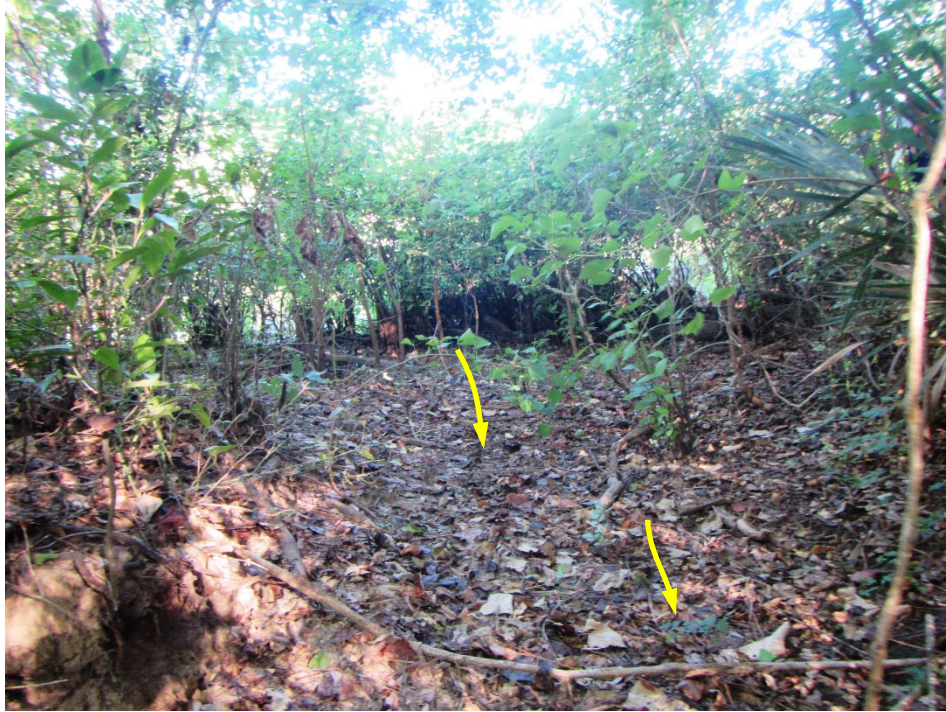
- Dense brush and small tree growth were observed obstructing the spillway approach and spillway channel.
- The spillway channel dimensions widened to approximately 15-feet wide and 6-feet deep about 25-feet downstream from the spillway approach. Encroaching overgrown vegetation was also observed along the channel banks and covering most of the channel at this location.

Photo 13. View of the spillway approach looking upstream. Note the dense brush and small tree growth obstructing the spillway approach. The direction of flow is noted by the arrows.

- c. All trees (regardless of size), non-grassy vegetation, and dry wood debris should be removed from within the spillway, inlet/outlet, spillway discharge channel, and downstream channel to ensure adequate flow conveyance.

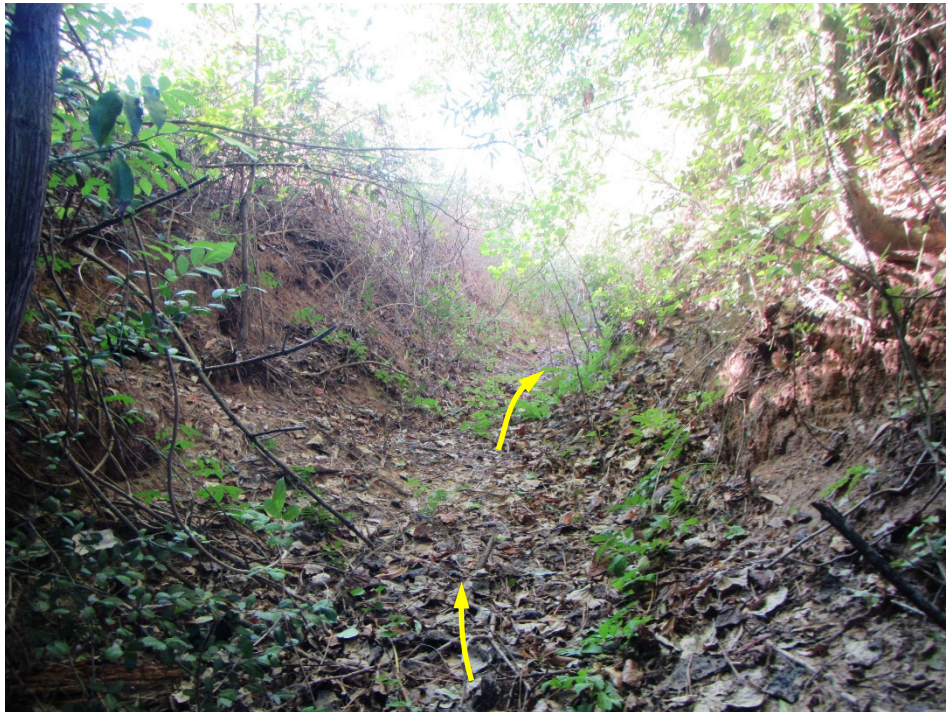
Photo 14. View of the spillway channel looking downstream. Note the vegetative growth along the channel banks encroaching on the spillway channel. The direction of flow is noted by the arrows.

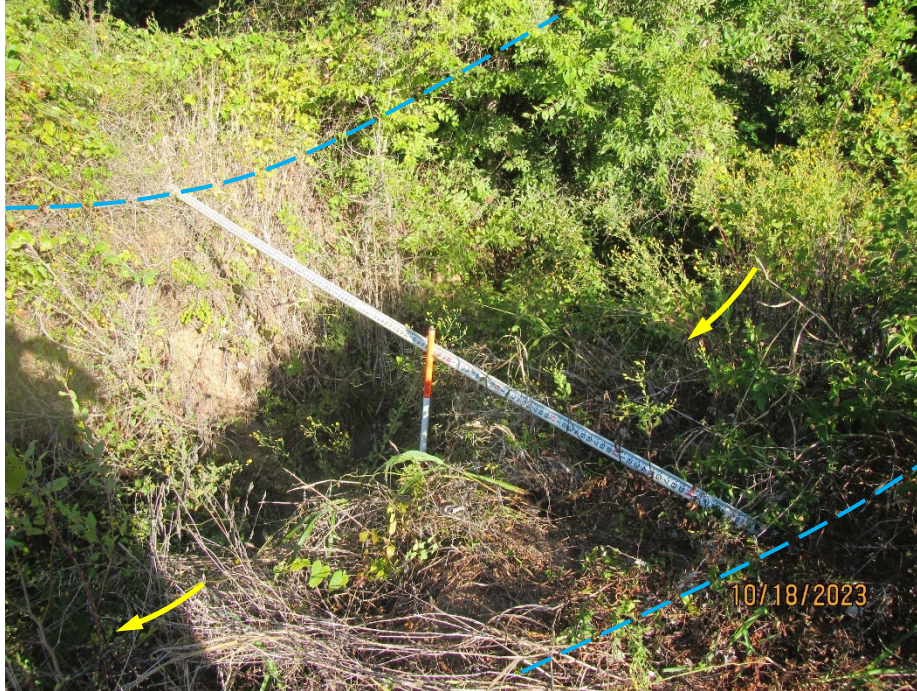
Photo 15. View of the obscured spillway channel (estimated dashed lines) looking upstream. The dimensions of the spillway channel were approximately 15-feet wide and 6-feet deep at this section of the channel with encroaching brush vegetative growth. The direction of flow is noted by the arrows.

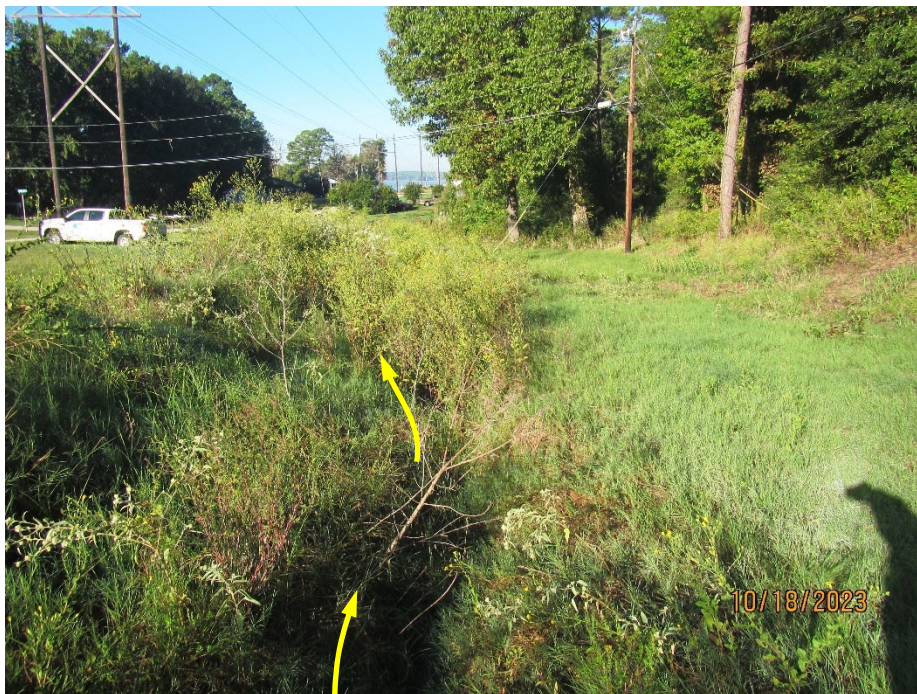
- A small relief channel had been excavated by the owner. The channel was about 2-feet deep and leveled out to the natural grade several feet before draining into the downstream pond.

Photo 16. View of the shallower section of the spillway channel (approximately 2-feet deep) looking downstream. The direction of flow is noted by the arrows.

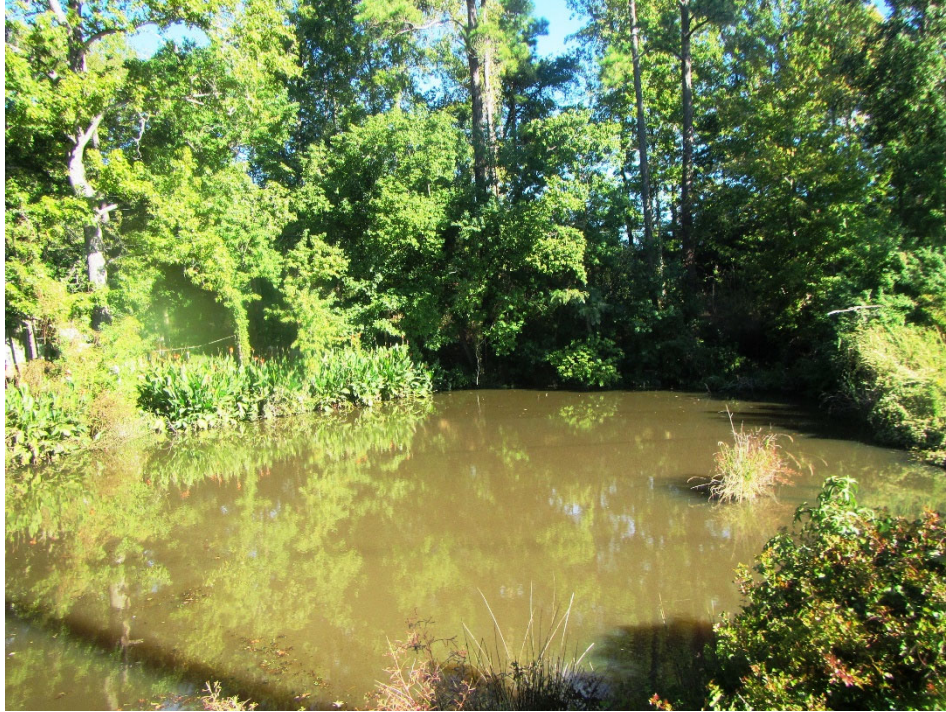
- The small pond located along the middle downstream toe area was slightly more overgrown with vegetation along the banks than in the last

inspection. The old spillway outlets are believed to be located along the toe area and pond; however, the outlets were not located.

Photo 17. View of the previously observed pond along the downstream toe area.

5. A small pond has historically been noted along the downstream toe area and believed to be the location of the old drop inlet outlet pipes. These pipes were not located or observed at the time of the inspection but should be further investigated.

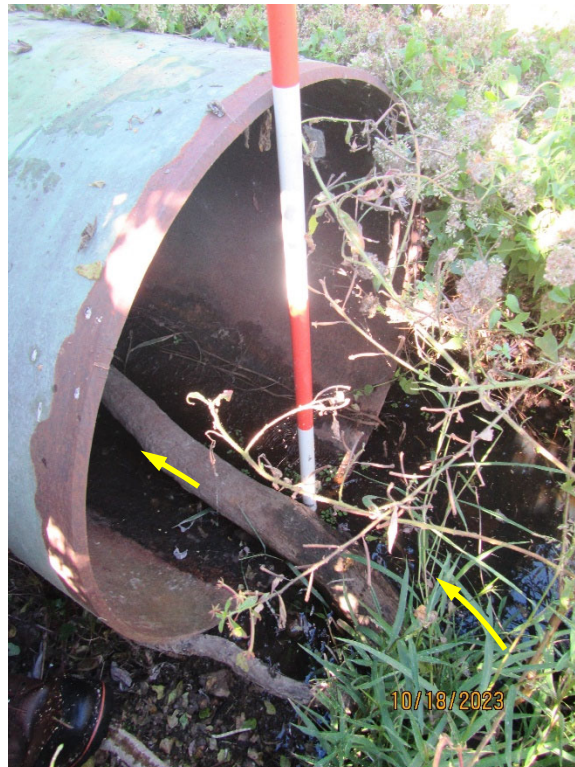
- A 3-foot diameter steel culvert drains and regulates the water elevation of the pond and spillway beneath East High Line Road. The culvert had some dry wood debris obstructing the inlet and was just engaged with flow at the time of the inspection.
- The area surrounding the culvert inlet was slightly more overgrown than in the last inspection.
- Flows from the culvert travel along a moderately defined and vegetated channel with dry wood debris and tree growth.
- The downstream channel was found in poor condition due to the possible obstruction of vegetative growth and scattered tree growth throughout the channel.

Photo 18. View of the 3-foot diameter steel culvert under East High Line Road. The culvert was obstructed with some dry wood debris and just engaged with flow from the downstream pond. The direction of flow is noted by the arrows.

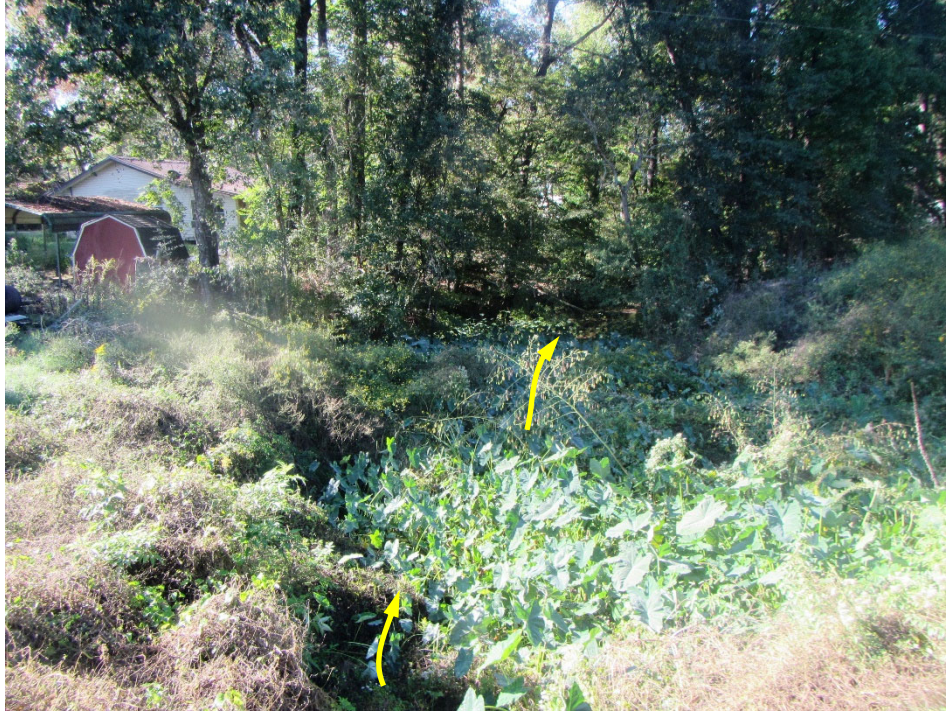
Photo 19. View of a downstream channel looking downstream from the roadway. Note the dense brush and tree growth along the channel and channel banks. The direction of flow is noted by the arrows.
